### FOREST LAKE

2023 Lake Management Study

Forest Lake Property Owners Association

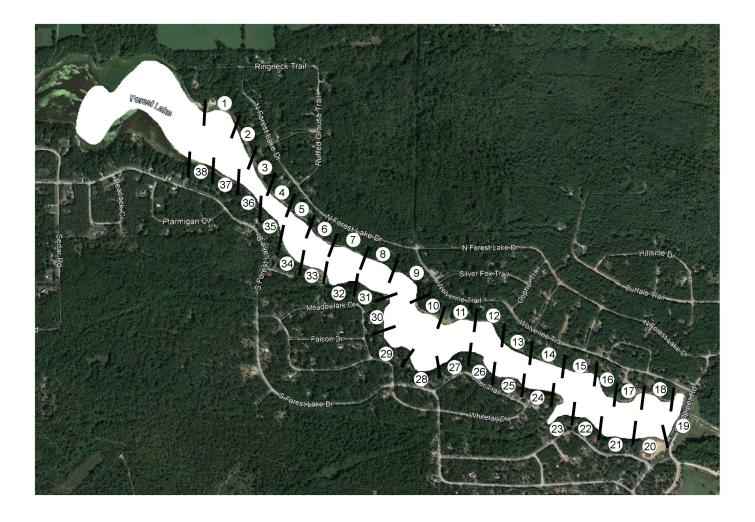
#### **AVAS Section Map**

A comprehensive vegetation survey called an Aquatic Vegetation Assessment Survey (AVAS), was performed on Forest Lake at the end of the year. During this survey, the lake is divided into evenly spaced sections. Inside each section, we document every type of aquatic vegetation found and determine its density inside of that section. Compiling all of these sections into a summary page, we determine a complete set of plant species found within Forest Lake and its approximate abundance.

There are 3 different sets of pages. The first is the summary page which gives you the lake wide plant coverage shown as an approximate percentage in column 11. Next is the lake map showing the numerous AVAS sections. The last set of pages are the density pages. Using the map and the density pages together you can determine what plant species exist in each section of the lake.

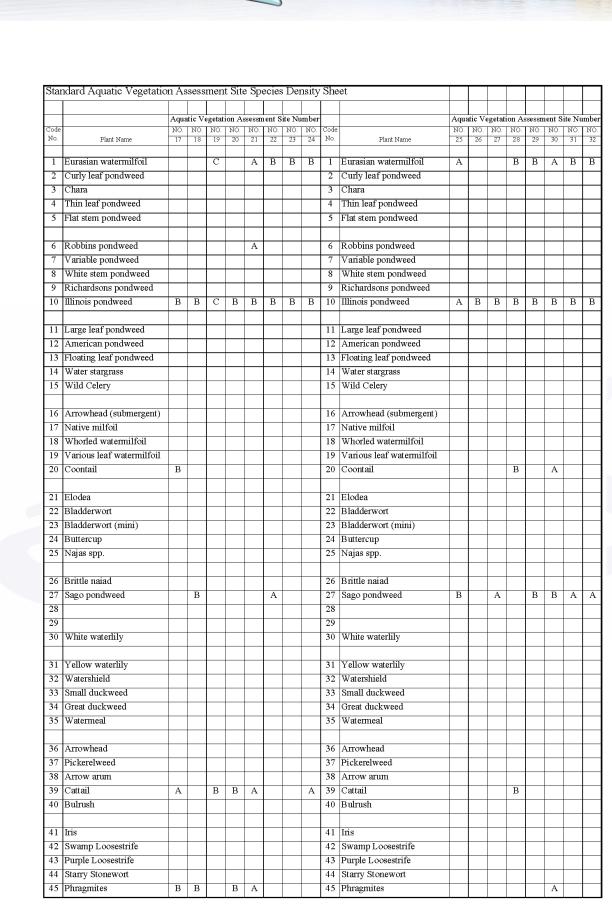
#### **AVAS Site Densities**

Looking through all of the pages will look very confusing if you do not understand what the numbers and letters mean. Each plant species has a 'code number'. You can see this on the summary and density pages on the left side. There are 4 different density categories:

- A = found, or <2% of the area
- B = sparse (2% 20%)
- C = common (20% 60%)
- D = dense (60% 100%)

When surveying the lake, we take the plant species number and pair it with a density rating for each AVAS section. We then compile the totals and the results are generated. The results are on the next couple of pages. As you can see, Eurasian watermilfoil and Illinois pondweed were the most prominent species found. The increase in abundance of milfoil was alarming and treatment most definitely should be accomplished in 2024. Phragmites was also observed along portions of the shoreline and should be treated as well in 2024.

It is recommended that a systemic treatment for Eurasian watermilfoil occur in 2024. Eurasian watermilfoil appears to have spread through the shallow northwestern portion of the lake and the immediate shoreline areas of the rest of the lake. Due to the shallowness and poor visibility in the water, we were not able to navigate the entirety of the northwest portion of the lake. Therefore a spring survey will be accomplished with an airboat to accurately determine the actual acreage of milfoil.

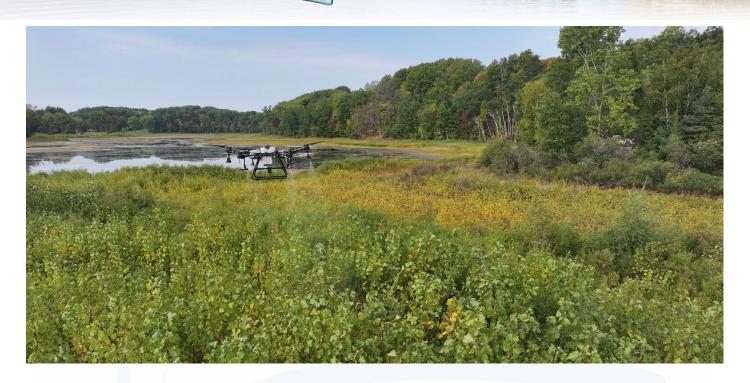
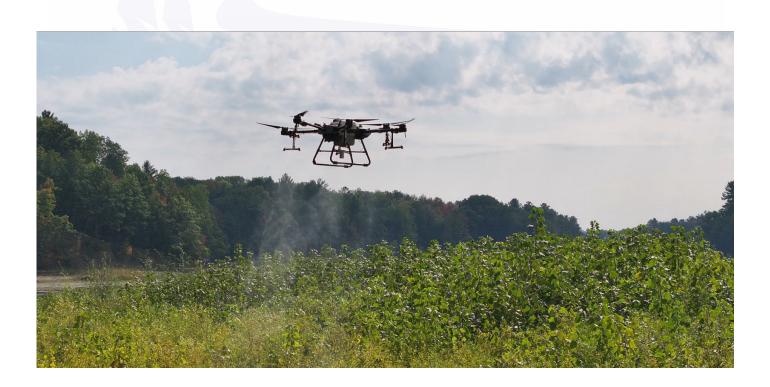
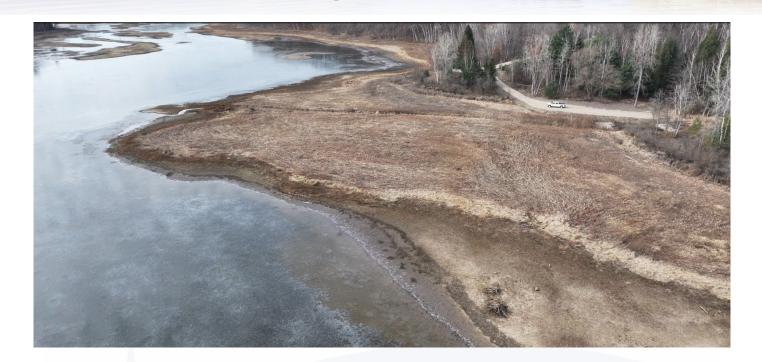
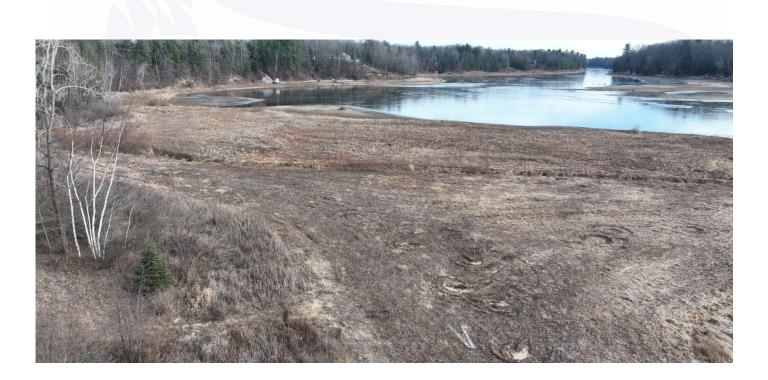
#### 2023 Drone Treatment

Treatment was conducted near the Seder Creek for woody species such as Cottonwood and Willows. This woody growth came from the exposed bottomlands of the lake due to the decreased water level. A herbicide application drone was used to accomplish this treatment using systemic herbicides on the woody plants. Once the systemic kill was accomplished, the dead woody plants were mulched at the end of the season. The following are pictures of the drone application and the area post mulching.

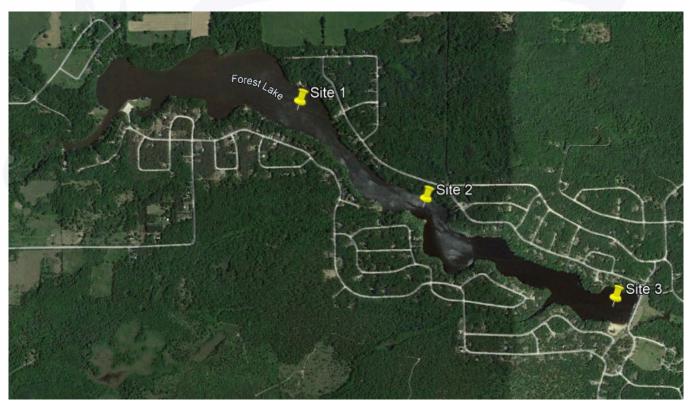
(Water Quality Sampling Sites)

Forest Lake had water samples taken on September 29<sup>h</sup>, 2023. Water samples were taken from sites 1, 2, and 3 for water quality testing. Fourteen parameters were analyzed from the water samples at these three sites for this report. Of the parameters tested, Temperature, Dissolved Oxygen, Secchi Disk, and pH were sampled while on the lake. Chlorophyll  $\alpha$ , Nitrate-N, Phosphorus, Alkalinity, Conductivity, Total Kjeldahl Nitrogen, Orthophospate, Total Dissolved Solids, Total Suspended Solids, and Turbidity were sampled by sending the water in sample bottles to an independent laboratory, White Water Associates located in Amasa, MI, where the analysis was ran. A complete lake profile for temperature and dissolved oxygen only was taken from site 3, which is the deepest part of the lake.

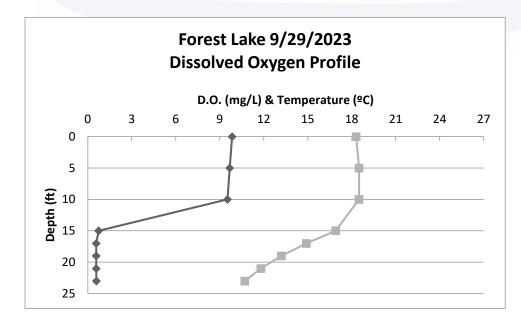
Temp	D.O.	Depth
(ºC)	(mg/L)	(ft)
18.3	9.84	0
18.5	9.67	5
18.5	9.52	10
16.9	0.73	15
14.9	0.57	17
13.2	0.57	19
11.8	0.57	21
10.7	0.58	23

Low dissolved oxygen concentrations (below 4 milligrams per liter) are generally insufficient to support fish life. In most Michigan lakes, there is no dissolved oxygen below the thermocline in late summer. Some experts like to see some dissolved oxygen in the bottom water of a lake, even if it is almost zero. This is because as long as there is some dissolved oxygen in the water at the bottom of the lake, phosphorus precipitated by iron to the bottom sediments will remain there. Once a lake runs out of dissolved oxygen in the water at the bottom iron comes back into solution. When that happens, it releases the phosphorus back into the water. This can cause additional algae to grow when the lake mixes.

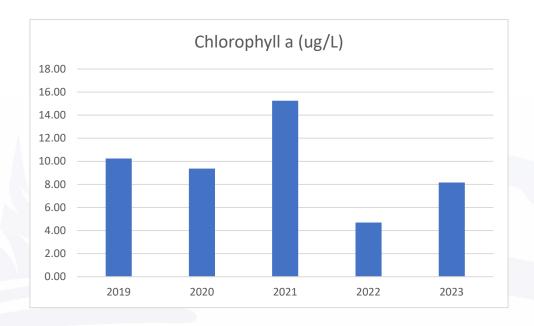
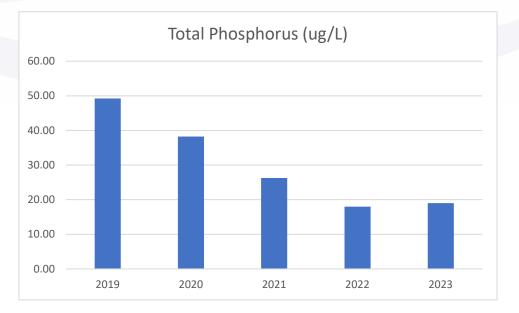
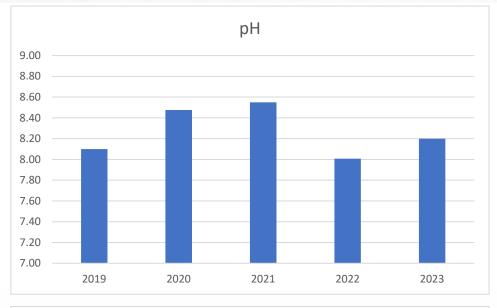
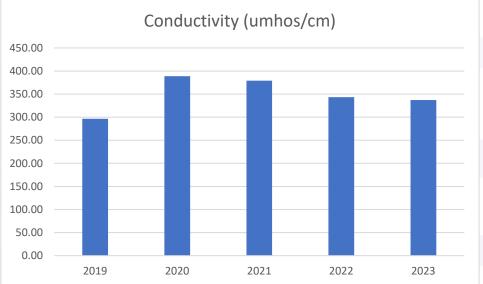
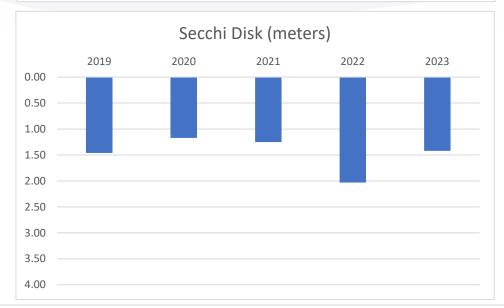
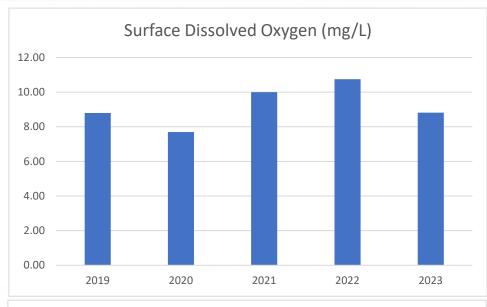
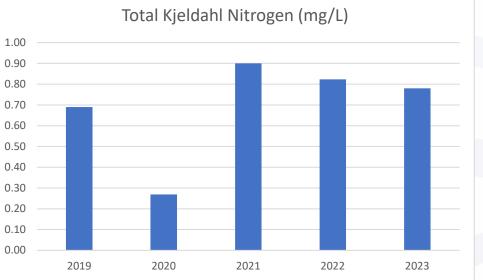
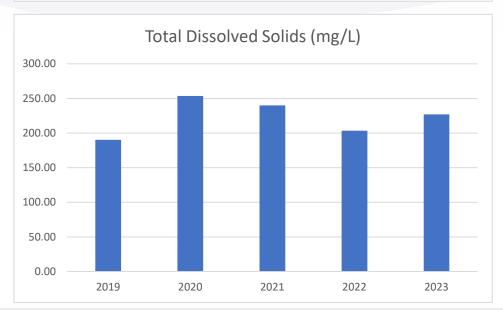
#### Water Quality Trend Graphs

The following are graphs showing recent trending for some of the previously tested water quality data. Data provided is an average of all values obtained in a particular year. Not all parameters have graphs provided. This is due to either having one or two years with data available, or having a majority of the data being unquantified. The most common reason for this is if the values were below the detection limit for the tests being run. For instance, Nitrate-N values are all below the detection limit of 130 ug/L in 2023.

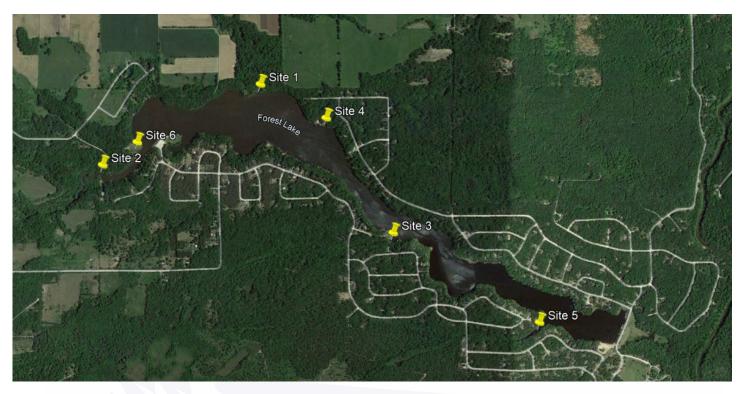
(Stream Sampling Sites)

Sediment samples were acquired in 2022 at the same 3 water quality sampling sites. Creeks were numerically labeled the same as previous studies for comparisons.

- Site 1: Seder Creek.
- Site 2: Wells Creek.
- Site 3: Whippoorwill Creek.
- Site 4: Ringneck Creek.
- Site 5: Bobcat Creek.
- Site 6: Park Road Drain.

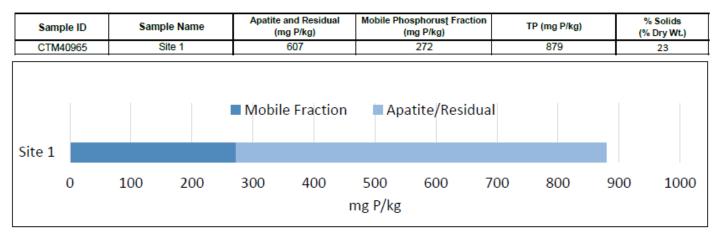
#### Sediment Data from 2022:

<sup>t</sup>Mobile phosphorus represents fractions of sediment phosphorus that are potentially bio-available in typical aquatic environments. All concentrations are reported based on dry weight

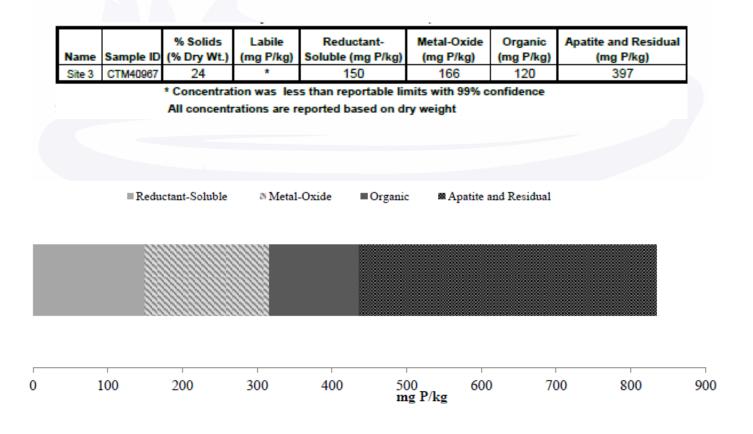
#### % Solids Apatite and Residual Mobile Phosphorust Fraction Sample ID Sample Name TP (mg P/kg) (mg P/kg) (mg P/kg) (% Dry Wt.) CTM40967 Site 3 594 240 834 24 Mobile Fraction Apatite/Residual Site 3 0 100 200 300 400 500 700 600 800 900 mg P/kg

<sup>t</sup> Mobile phosphorus represents fractions of sediment phosphorus that are potentially bio-available in typical aquatic environments. All concentrations are reported based on dry weight
